White Paper

STEEL WINDOW RESTORATION
EFFECTIVE STRATEGIES TO
RESTORE AND UPGRADE HISTORIC
STEEL WINDOWS

by Arthur Femenella, Sr. President
Femenella & Associates, Inc.

William J. Nealon Federal Courthouse
Scranton, Pennsylvania

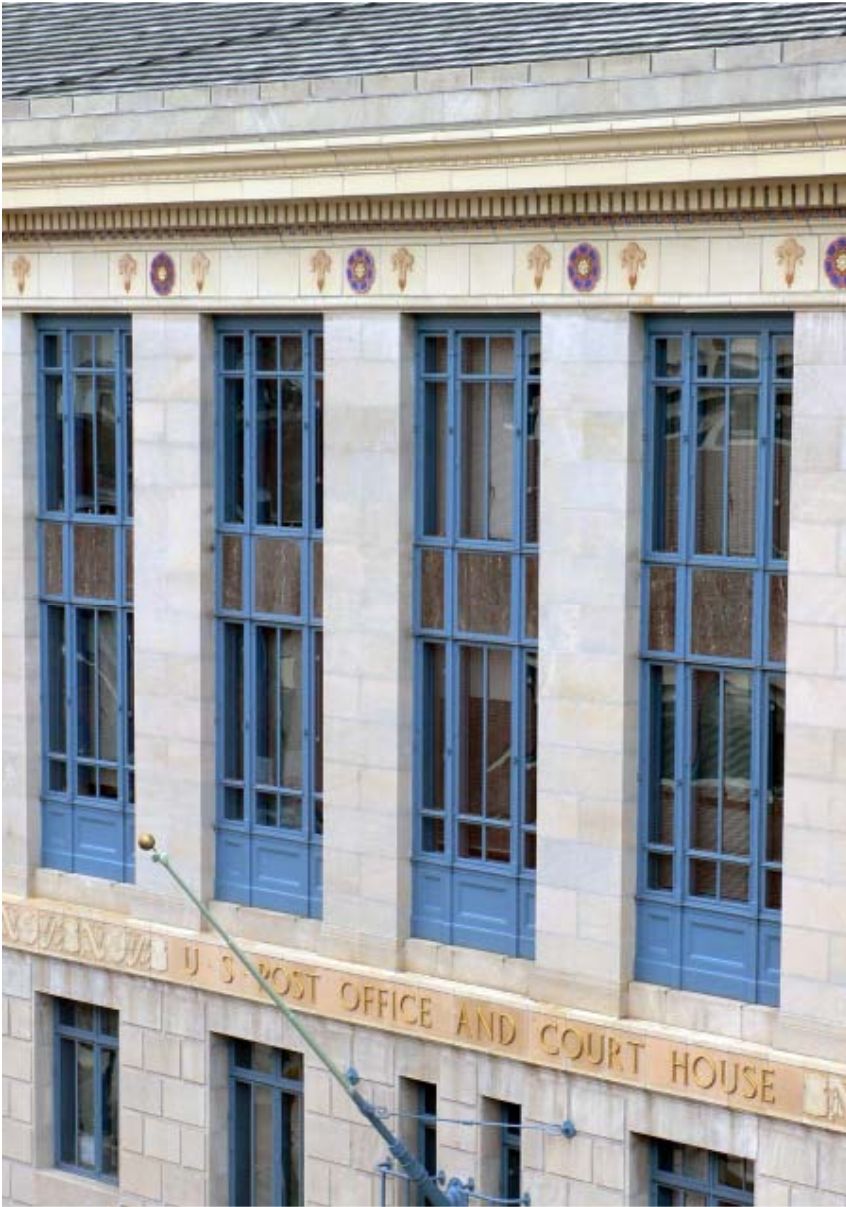
The 284 steel windows of the Nealon Courthouse were restored by Femenella & Associates, Inc. working in concert with C&D Waterproofing under the direction of RJMJ Architects. The project included 34 monumental windows that span the 3rd & 4th floors with cast iron ornament and marble spandrel panels. Numerous upgrades were made to the windows during the project to increase energy efficiency, ensure proper water drainage and resistance to corrosion.

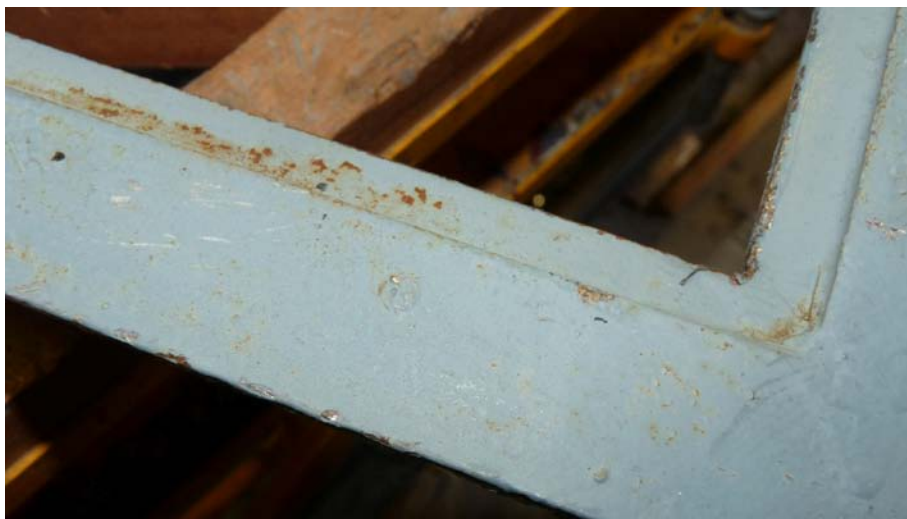
MINOR CORROSION

If the windows exhibit minor corrosion with no rust jacking, and the paint is in fairly good condition, repairs can typically be completed in situ. For remediating minor corrosion and damage, complete the following:

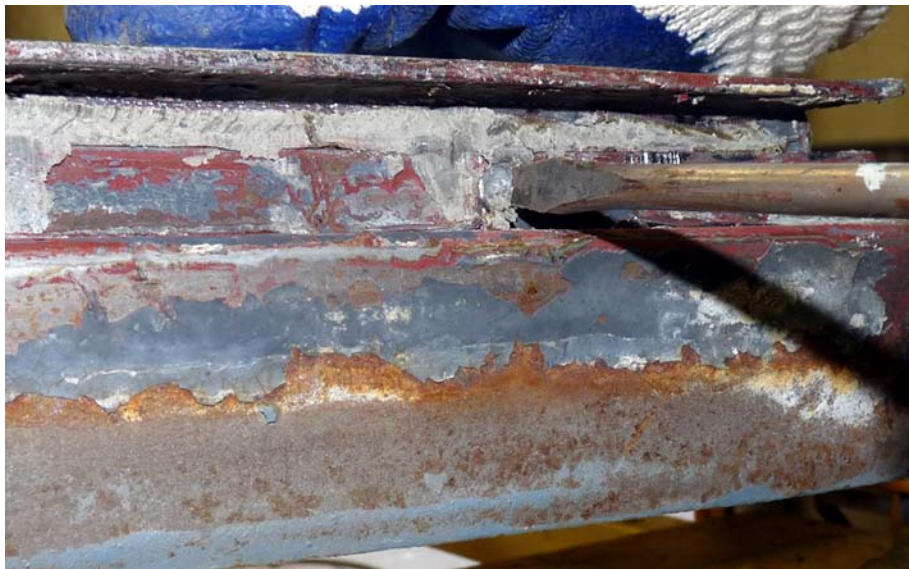
MODERATE CORROSION

For windows with moderate corrosion, the above steps outlined for minor corrosion are followed as well. In addition, minor straightening of the sash or frame may be required.

1. To straighten the sash in situ, remove the glass and glazing. Using a wood or metal member to distribute the load, use clamps or an improvised come along to exert pressure on the affected window member. Often, due to "metal memory" the section has to be forced slightly beyond the ultimate desired plane to effect a good fit. The frame can be returned to plane in a similar manner.
2. Corrosion may be so great that the proper closing of the sash is not possible. In these conditions, grind the uneven portion of the frame or sash back to its original design plane.
3. Moderate corrosion may result in divots or uneven surfaces once the corrosion is removed. These can be filled with special epoxies impregnated with steel filaments that are designed for these repairs.

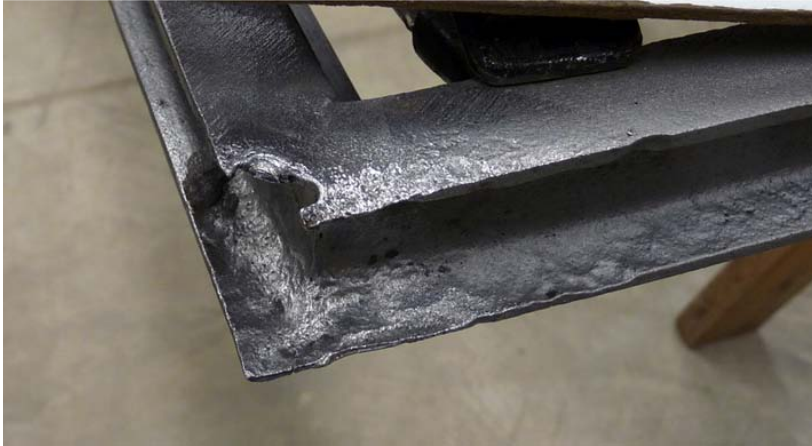
SEVERE CORROSION

Windows exhibiting severe corrosion can often be economically and effectively restored by qualified craftsmen with extensive field experience. Severe corrosion is evidenced by sections of the sash or frames that are corroded to the point they have no structural integrity; severely deformed or misaligned frames or sash; or missing metal sections. Again, all of the methods discussed to solve minor and moderate corrosion are employed first.

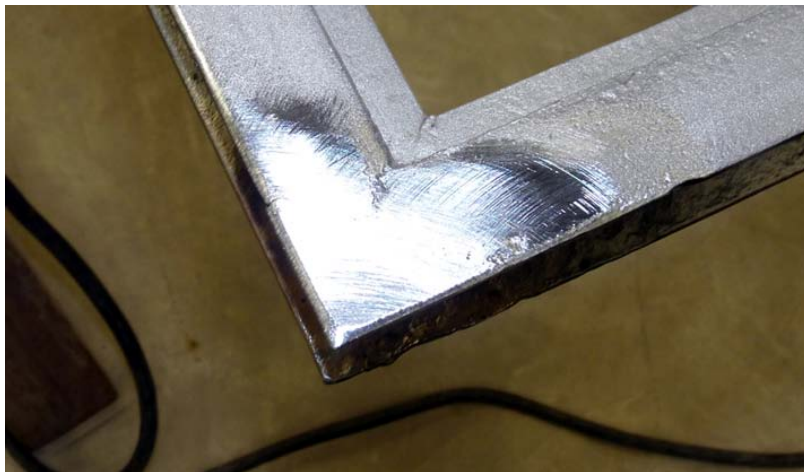
1. Window sash and frames that exhibit severe corrosion typically must be repaired in the shop. As mentioned above, determine how much of the window can be economically dismantled and treated off site.
2. Once in the shop, abrasive blasting is the best way to remove paint and corrosion. This allows a very clean surface for welding patches or applying steel filled epoxy.
3. Severe corrosion as pictured above can be repaired by cutting away material back to the solid metal. New metal is then welded to the old, rough cut to shape and ground down to the original profile. The result can be seen below.

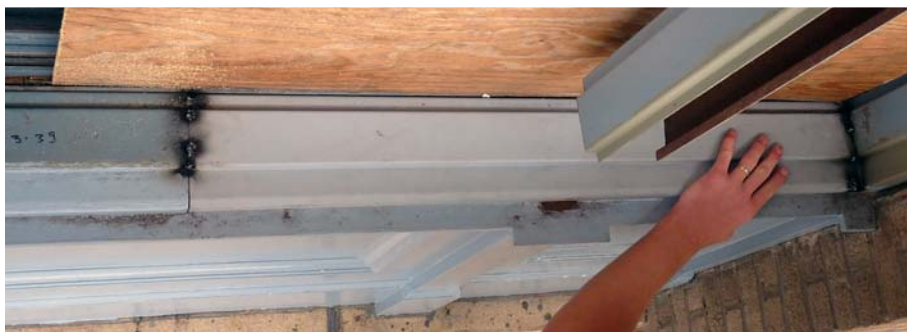
- The subframe assembly at Nealon had to be repaired in situ. This involved the cutting out and replacement of sills and headers. We had runs of the various profiles fabricated. At the site, damaged sections were cut away leaving plumb and straight edges. New sections were cut and welded in place.

Photo of replacement section tack welded in place. There is a stainless steel backing plate that spans the joint. Welds will be made continuous along the joint and ground flat to the profile. Where required, epoxy patch material will be added.
