Case Study

Emma Willard School

An Overview of the extraordinary window restoration project at Emma Willard School—the largest of its kind in the United States.

Prepared by: Arthur J. Femenella, Femenella & Associates
October 2010

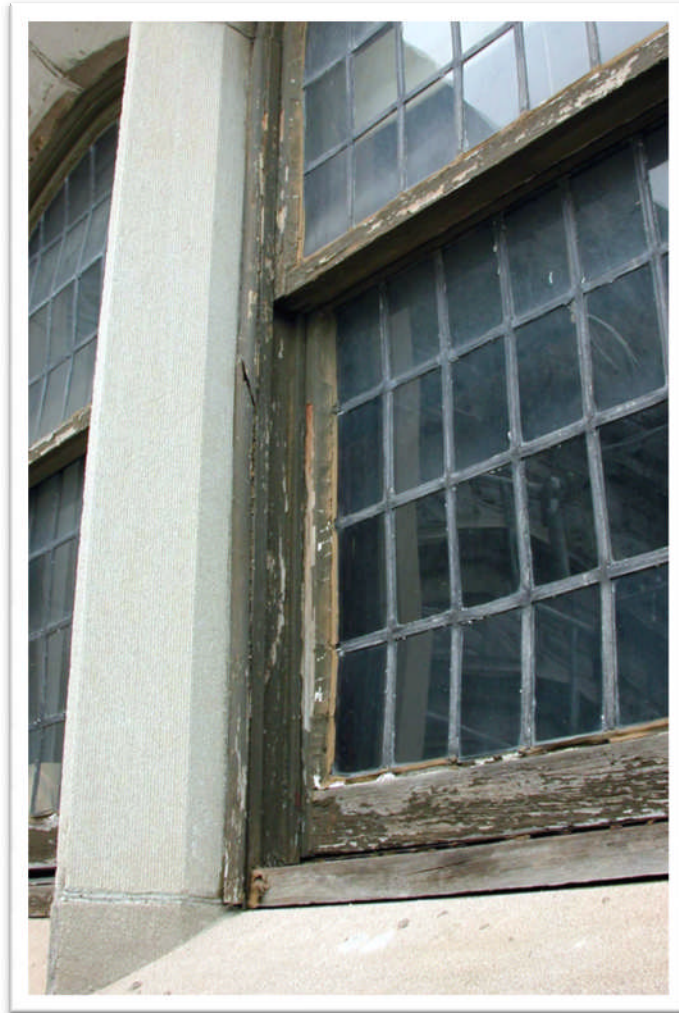
Figure 1-Typical wood and leaded glass window before restoration

The windows at Emma Willard were built by talented craftsmen from top quality materials. They had long suffered from freeze thaw cycles, ultraviolet radiation from the sun and the intrusion of water from rain and melting snow. These forces had destroyed the protective layer of paint and had leached out the natural oils of the wood frames and sashes. The lead came matrices of the windows had succumbed to metal fatigue caused by the constant movement of the metal in response to expansion and contraction forces. Some of the glass had broken as the windows deflected beyond what the tensile strength of the glass could bear.

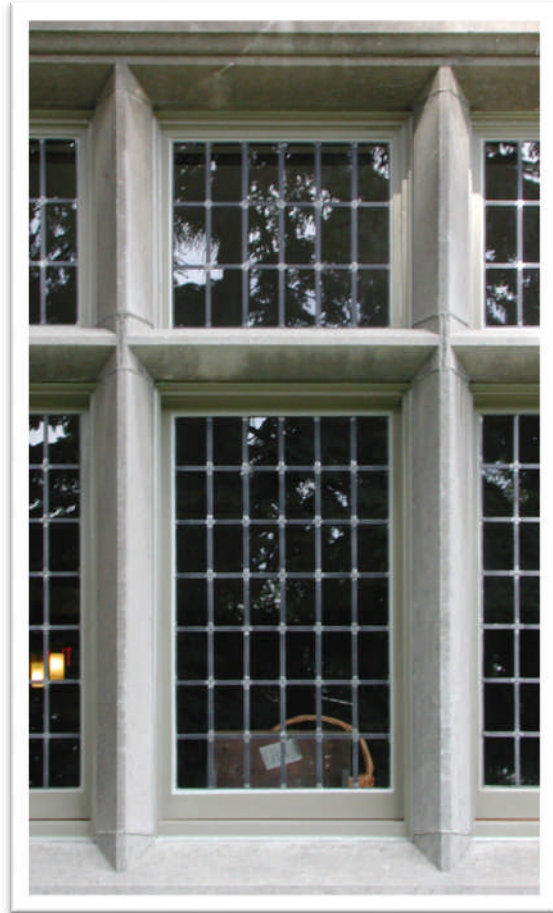
Figure 2-Window after restoratio

As much of the original fabric as possible is saved. We use Dutchman repairs where needed fabricated from old growth eastern white pine. Areas of deterioration not requiring Dutchman repairs were consolidated and filled with epoxy products specifically designed for the purpose. After sanding of the repairs and epoxy patches, the sash were given two coats of a "natural" consolidant, boiled linseed oil, spar varnish and a water repellent. The exterior was painted with an oil base primer and two topcoats of latex paint. The interior was a bit more complex, receiving a copy of the original 7 step faux finish to mimic dark oak. The frames were treated in a similar manner as the sash.

A big goal of the project was to make the windows more thermally efficient. To this end, we did the following. The upper sashes were made fixed; not permanently so, nothing was done that was irreversible. This allowed for the caulking of the upper sash and made the upper connection at the meeting rail immovable, resulting in a better seal at the meeting rail weather stripping. New integral weather stripping was installed. The weather strip is fabricated from spring bronze and the receiving strip on the sash is lined with heavy felt virtually eliminating all infiltration.

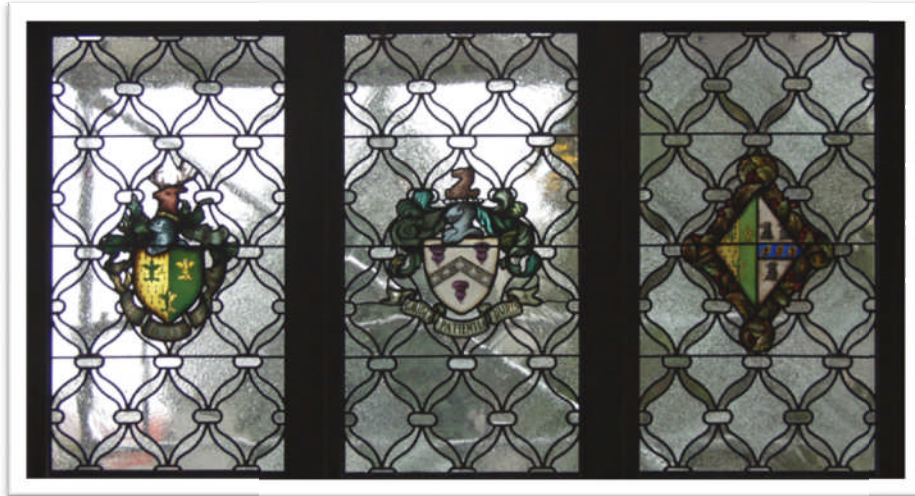
Figure 3-Stone set stained glass windows after restoration

For the leaded glass, a lead alloy containing copper, tin and antimony will greatly extend the life of the lead came matrix. To further support the matrix (some of the panels are very large and exceed the recommended maximum size) we augmented the original support system. Originally, the panels had a series of horizontal flat bars soldered onto the panels and let into the sash at the perimeter. We amended this system to include an internal steel bar at every horizontal lead that runs full width of the panel and a series of applied flat bars that run vertically and are let into the sash at the perimeter of the panels. To effect this change, we did not use the original glass because each piece would have to be trimmed 1/8" to allow for the internal bars. We had determined early on in the project in consensus with the staff of the school that the individual pieces of glass were not as important as the overall aesthetic that the multi-paned windows afforded the building. The glass was highly polished, had no visual movement and was perfectly copied with new glass. These panels were set into a flexible caulk system.
